CYCLIC SHEAR LOAD TESTS ON SEISMICALLY STRENGTHENED MASONRY WALLS

Abstract

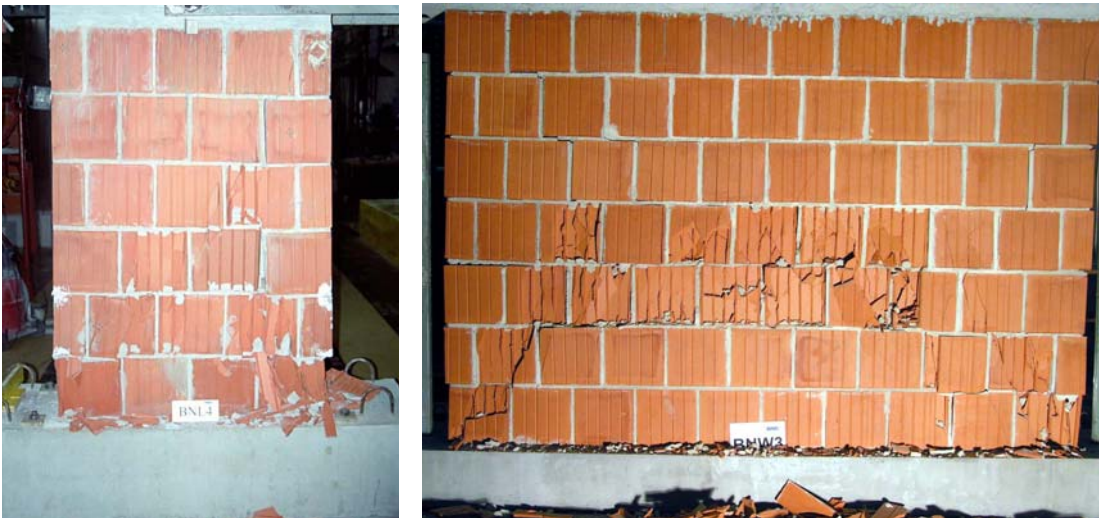
In general, earthquake performance of unreinforced masonry (URM) shear walls is unsatisfactory. Under strong motions a brittle shear failure could be expected. The failure mode is also strongly influenced by the wall's geometry; see for example Figure 1 [Bosiljkov 2008] for failure patterns of two walls with different aspect ratios. Both walls failed in shear: the short wall exhibited a typical diagonal tension shear failure, the long wall a combined sliding and diagonal tension shear failure. Within the framework of a research project at ETH Zurich, the possibility of improving such poor performance by strengthening URM walls with prefabricated elements was investigated. The main goal of the research project is, based on the series of full scale load tests, to investigate the influence of these strengthening elements on structural behaviour of masonry walls under static-cyclic shear loading [Becker 2010].

Figure 1. Performance of URM walls subjected to cyclic load [Bosiljkov 2008].

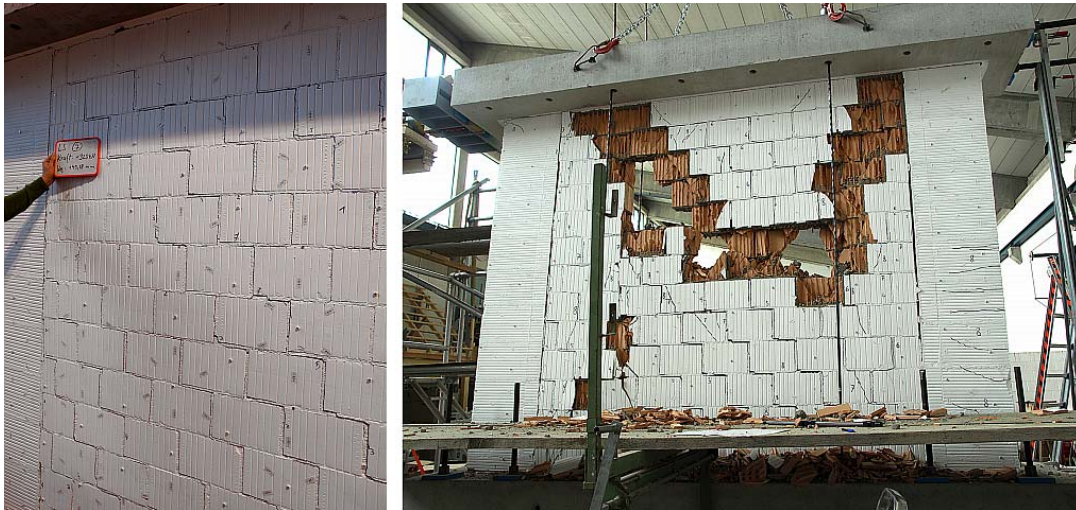
Specimen S1 was tested without a pre-compression load. This specimen developed cracks along head and bed joints thus forming the characteristic staircase-shaped crack pattern, see

also Figure 10. For higher load levels a major crack between the strengthening element and the lower spreader beam opened up. This crack has grown extensively during testing. The upper spreader beam was damaged at the surface of contact with the strengthening element, thus forming quasi-plastic bending hinge in the frame. In order to prevent such behaviour, in subsequent tests the strength of the upper spreader beam was increased.

Figure 10. Failure patterns of specimens S1 and S2.

The first cracks in specimen S2 appeared between the wall and the lower spreader beam as well as between the wall and strengthening elements. Major cracks appeared in the middle area of the URM wall following the staircase-shaped pattern described above. In addition to the cracks in joints, cracks in clay blocks were also observed, see Figure 10. After failure of the URM wall it was possible to apply an additional horizontal force of 169 kN, which was carried solely by the strengthening elements.
